## ACOUSTICAL FIELD TEST REPORT

**PROJECT: Lake Park Estates  
Richardson, TX**

## ACOUSTICAL PERFORMANCE TEST REPORT

Report No: 70722.01-113-10  
Revision 1: 03/07/07  
Test Date: 02/22/07  
Report Date: 02/27/07  
Expiration Date: 02/22/11

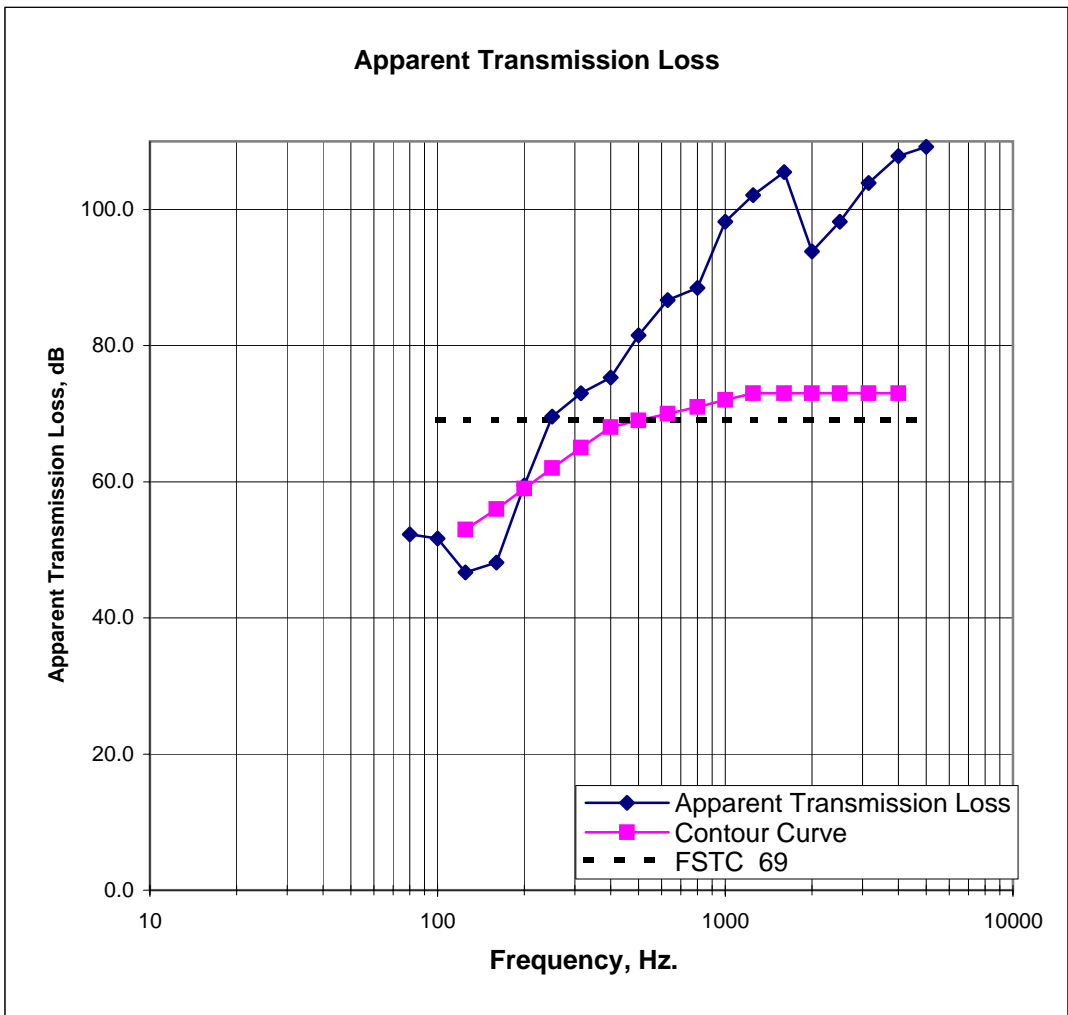
**ASTM E336 Apparent Sound Transmission Class**

ATI Report No. 70722.01A-113-10  
 Test Date: 2/23/07  
 Customer: Knight Industries  
 Project: 1250 Jonssen Blvd., Richardson, TX  
 Test Area: Parting Wall  
 Specimen Type: Bedroom to Living Room, 1st Floor  
 Sample Area: 133.7 Square feet  
 Receive Room Volume: 3087 Cubic feet  
 Source Room Volume: 1473 Cubic feet  
 Technician: TDK/JS

Freq. (Hz)	Apparent Transmission Loss (dB)
80	52
100	52
125	47
160	48
200	59
250	70
315	73
400	75
500	82
630	87
800	88
1000	98
1250	102
1600	106
2000	94
2500	98
3150	104
4000	108
5000	109

ASTC Rating = 69

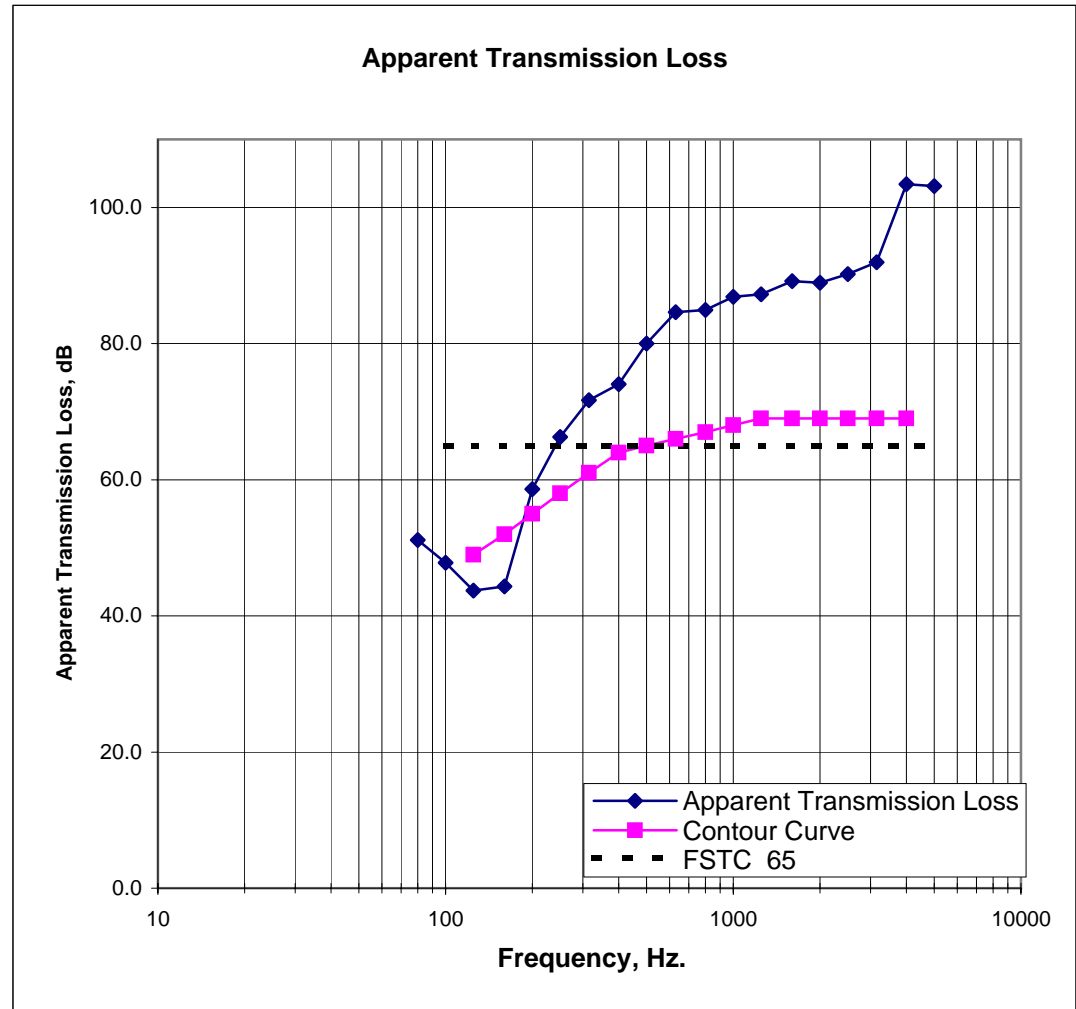
**ASTM E336 Apparent Sound Transmission Class**

ATI Report No. 70722.01B-113-10

Specimen Type: Bedroom to Bedroom, 2nd Floor

Freq. (Hz)	Apparent Transmission Loss (dB)
80	51
100	48
125	44
160	44
200	59
250	66
315	72
400	74
500	80
630	85
800	85
1000	87
1250	87
1600	89
2000	89
2500	90
3150	92
4000	103
5000	103

ASTC Rating = 65

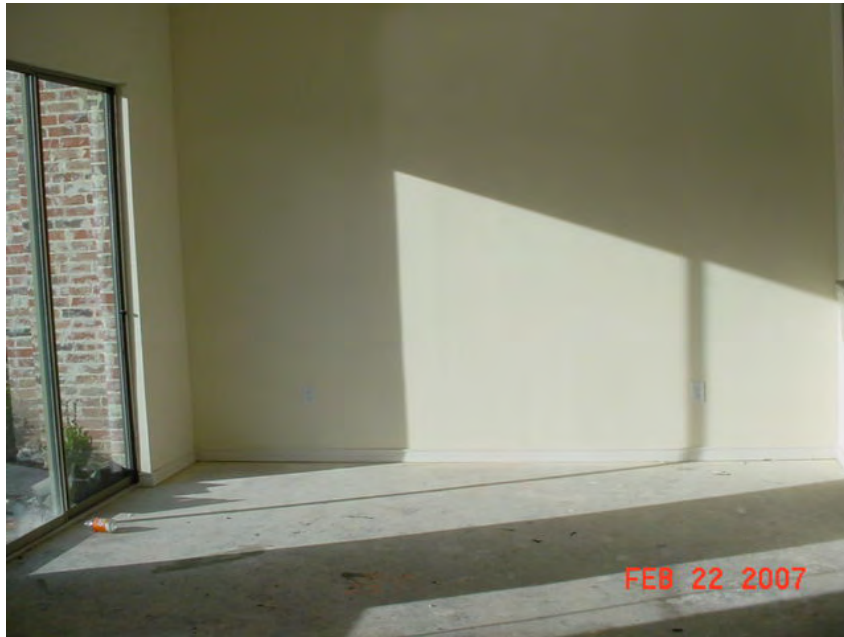
**Wall Partition in Condominium 2007 Living Room**

**Test Area 1:** 1<sup>st</sup> Floor: Wall partition between condominium 2009 bedroom and condominium 2007 Living Room

Layer	Description
1	5/8" gypsum board
2	Sound Stop <sup>®</sup>
3	3-5/8" wood stud with 3-1/2" Rocwool insulation between studs
4	5/8" gypsum board
5	1" air space
6	5/8" gypsum board
7	3-5/8" wood stud with 3-1/2" Rocwool insulation between studs
8	Sound Stop <sup>®</sup>
9	5/8" gypsum board

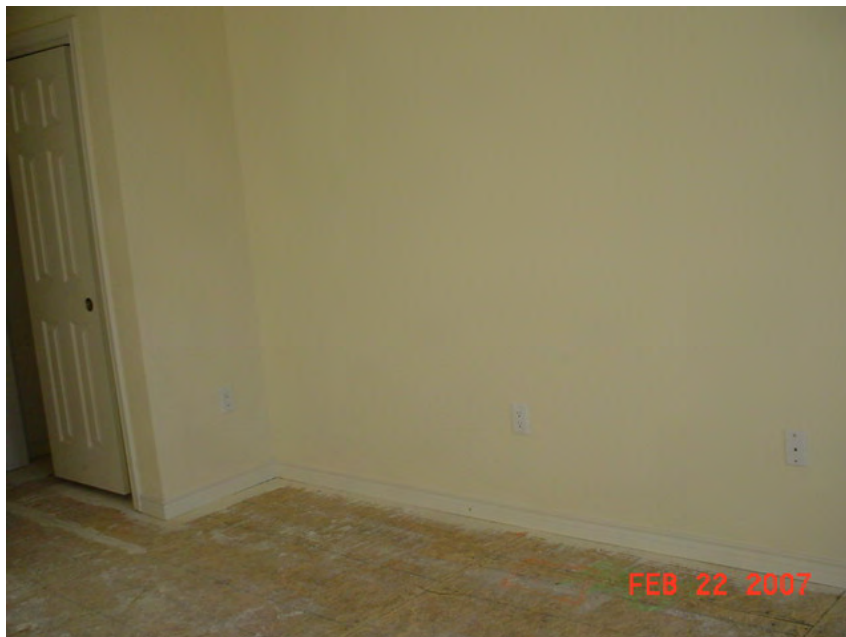
**Wall Partition in Condominium 2009 Bedroom, Second Floor**

**Test Area 2:** 2<sup>nd</sup> Floor: Separating wall between condominium 2009 bedroom to condominium 2007 bedroom

Layer	Description
1	5/8" gypsum board
2	Sound Stop <sup>®</sup>
3	3-5/8" wood stud with 3-1/2" Rocwool insulation between studs
4	5/8" gypsum board
5	1" air space
6	5/8" gypsum board
7	3-5/8" wood stud with 3-1/2" Rocwool insulation between studs
8	Sound Stop <sup>®</sup>
9	5/8" gypsum board
